Sedimentation Patterns in a Stabilized Migratory Inlet, Blind Pass, Florida

Wang, P., Tidwell, D. K., Beck, T. M., and Kraus, N. C. 2007. Sedimentation Patterns in a Stabilized Migratory Inlet, Blind Pass, FL. *Proceedings Coastal Sediments '07 Conference*, ASCE Press, Reston, VA, 1377-1390.

SEDIMENTATION PATTERNS IN A STABILIZED MIGRATORY INLET, BLIND PASS, FLORIDA

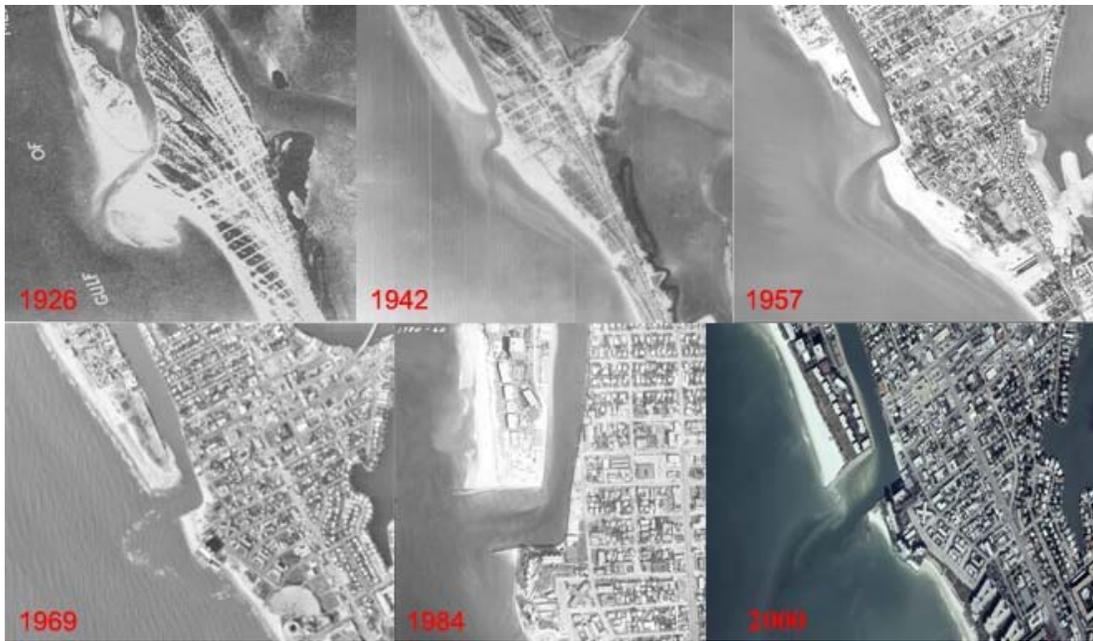
Fig. 2. Time-series aerial photos of Blind Pass.

Artificial interferences on the morphodynamics of Blind Pass are illustrated well by time-series aerial photographs (Fig. 2). Blind Pass is characterized by a nearly 90-deg. turn before entering the Gulf of Mexico. We focus on the entrance channel at and gulfward of the turn. In 1926 (Fig. 2A), the inlet was still in pristine condition. A large ebb shoal and southward sand bypassing are apparent. By 1942 (Fig. 2B), the south side had been stabilized. The ebb delta and southward bypassing are still visible, but to a reduced degree. Beach erosion at Treasure Island to the north becomes obvious. By 1957 (Fig. 2C), the ebb shoal and southward bypassing are still visible. At the same time, erosion at the updrift Treasure Island had become severe. By 1969 (Fig. 2D), both sides of the inlet were stabilized. The ebb shoal and southward bypassing diminished substantially. Through a combination of jetty, groin field, and beach nourishment, erosion at the updrift Treasure Island was mitigated. However, severe erosion at downdrift Upham Beach to the south developed. Shoaling of the inlet channel and severe erosion downdrift are the main features of the 1984 photo (Fig. 2E), which was taken a year after the 1983 dredging. The ebb shoal and southward bypassing become indistinguishable. This trend continued and is shown in the 2000 photograph (Fig. 2F) just before the last dredging to date. The present study on shoaling in the channel was commenced after the 2000 dredging.

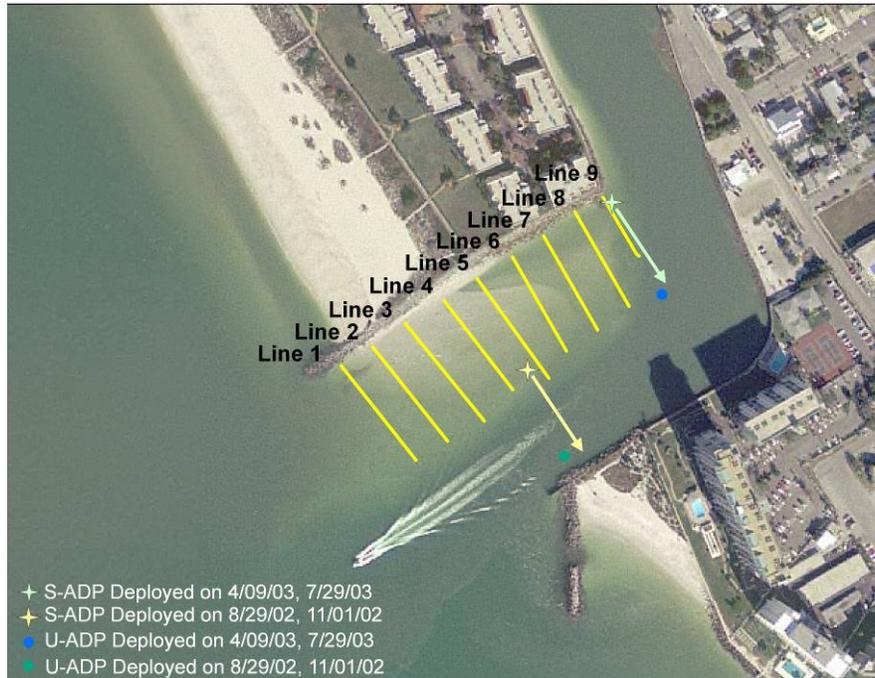
Fig. 3. The north shoal profiles and locations and times of current meter deployments.

The present study examines sediment shoaling in the Blind Pass entrance channel via a series of field investigations, through which a numerical model of circulation was established. Time-series bathymetric surveys were conducted, as well as flow measurements. Bathymetric surveys were conducted roughly quarterly from August 2002 to June 2004. The surveys were conducted with a combination of precision echo sounder for depth and a synchronized Real-Time-Kinematic (RTK) Global Positioning System (GPS) for position. Water level variations were measured to cross-check the tidal influence on the floating platform survey. During the study, the northern side of the inlet became too shallow to survey by boat. Level-and-transit surveys using an electronic total station were conducted there monthly from February 2003 to February 2004. The monthly survey of 9 lines over the northern shoal, extending to roughly 1.5 m water depth, was designed to capture the infilling rate and pattern over this active shoaling area (Fig. 3). Surveys are referenced to NGVD29, which is roughly 0.15 m below mean sea level in this area.

Tidal flow patterns through the inlet were measured using an upward-looking acoustic Doppler current profiler (U-ADP) in combination with a side-looking ADP (S-ADP). Therefore, flow patterns both through the water column and across the channel were measured. The flow measurements were conducted at two locations with one near the mouth and one near the bend, each for approximately one month (Fig. 3). In addition, flow velocities were measured simultaneously using two U-ADP placed in the thalwegs near the entrances of Johns Pass and Blind Pass. These data are valuable for examining the interaction of the two inlets and for validating the circulation model.

Sedimentation on the north shoal was monitored through monthly surveys of nine lines (Fig. 3). Four areas with different patterns of accumulation and erosion in the shoal can be distinguished as the: mouth area (lines 1 and 2), middle area 1 (lines 3 and 4), middle area 2 (lines 5 and 6), and the inner area (lines 7 through 9). From February to August, or the summer of 2003, a considerable amount of scour occurred in the mouth area (Fig. 11A). Little change was observed during the next two months. A tremendous amount of shoaling occurred in the mouth area between October and December of 2003, or at the beginning of the winter season. Scour was measured during the late winter between December 2003 and February 2004. Further into the inlet in middle area 1, little change occurred during the summer (Fig. 11B). A large amount of shoaling occurred at the beginning of winter, followed by further accumulation during late winter. Even further into the inlet at middle area 2, little change was observed during most of 2003 (Fig. 11C). A tremendous amount of shoaling occurred in the late winter. Near the bend of the inlet at line 9, southward progradation of the shoal occurred throughout the year (Fig. 11D). A large amount of shoaling was also observed during late winter.

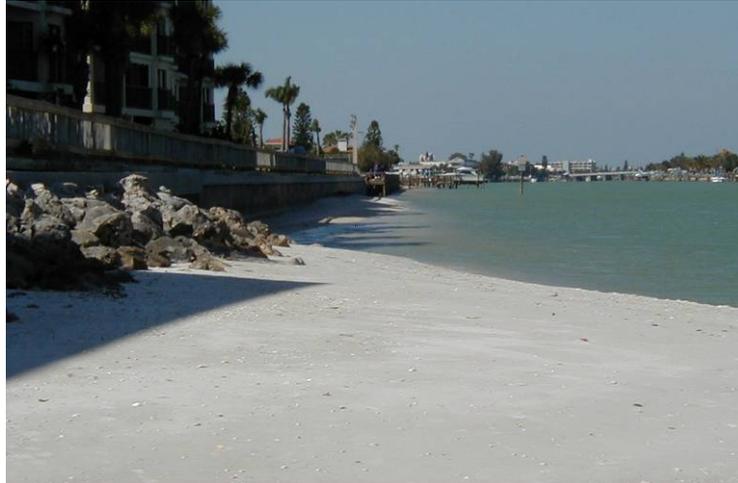
Fig. 10. Beach development along the back side of Treasure Island at Blind Pass, looking north.

From August 2002 to August 2003, net sedimentation of 17,000 m³ occurred, as the sum of 25,000 and 2,800 m³ accumulation from August 2002 to December 2002 and from August 2002 to May 2003, respectively, and 11,000 m³ of erosion from May 2003 to August 2003. From August 2003 to June 2004, net accumulation of 26,000 m³ occurred. For both years, net accumulation occurred in the winter months and net erosion in the summer months. This seasonal trend is reflected more clearly in the monthly north-shoal survey, discussed in the following. The reduced amount of sedimentation during 2003 and 2004 is related to sediment backpassing around the corner of the inlet. A beach has developed on the back side of Treasure Island since 2003 and is growing (Fig. 10).

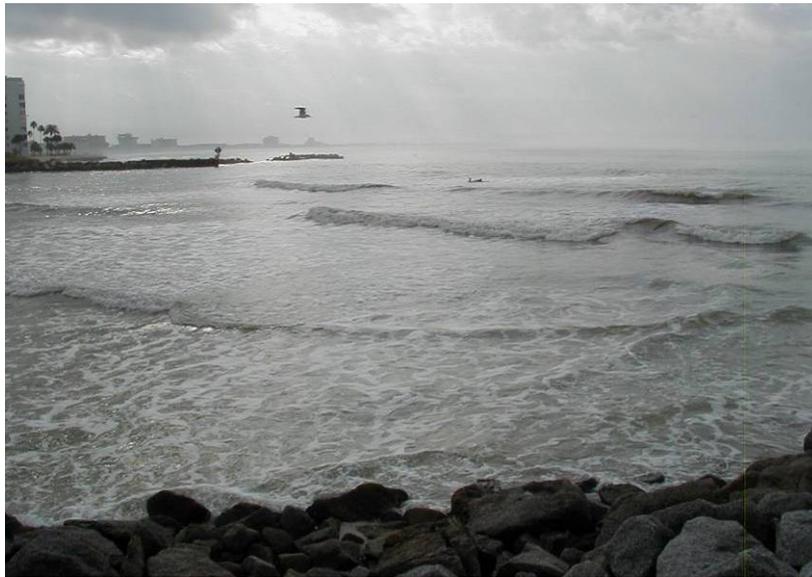
Fig. 11. Wave breaking and surf bores over the north shoal. Looking south.

The relatively strong flood current over the north shoal is a major mechanism transporting sand further into the inlet and around the bend to the back of Treasure Island. This has effectively limited development of an ebb shoal at Blind Pass. In addition to the flood current, wave breaking over the shallow north shoal and the resulting landward moving surf bore should also contribute significantly to landward sand transport, especially during high waves (Fig. 11). The development and significant growth of the beach on the back side of Treasure Island are results of the landward sand redistribution, in contrast to typical seaward sand transport by ebb flow and development of an ebb shoal.
